# Weston ENGINEERING NOTES

VOLUME 1

DECEMBER 1946

## *In This Issue*

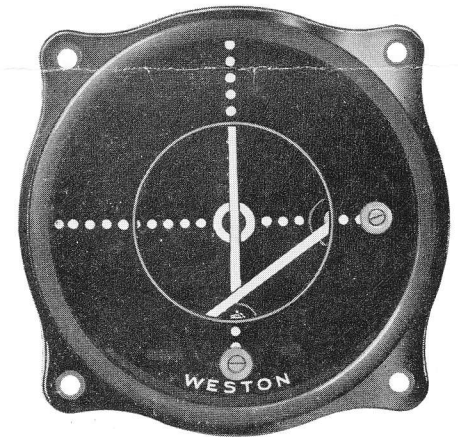
Figure 1—An early Weston blind landing indicator developed in 1933.

Subsequent tests of this system utilized a Weston Model 635 Crossed Pointer Indicator which had been developed for this particular requirement. See Figure 1. The crossed pointers of the indicator, one operated from the localizer signal and the other by the

landing beam or glide path signal, presented a visual interpretation of the position of the aircraft relative to the location of the fixed directional radio beams transmitted by the associated ground equipment.

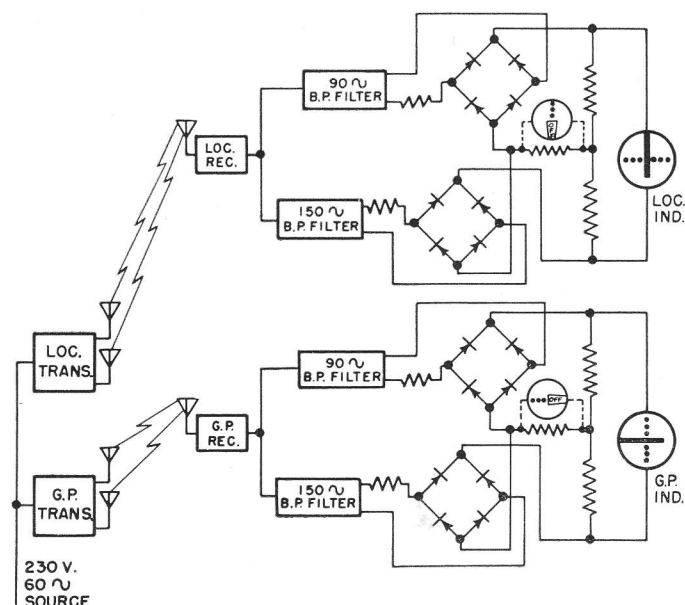
Figure 2—Simplified block diagram of the blind landing transmitting and receiving equipment.

receiving equipment likewise presented many problems from the standpoints of circuit details, stability and durability of circuit elements. These problems have now been largely resolved and the resulting simplified block diagram of the receiving equipment is approximately as shown in Figure 2.

In one system resulting from these efforts the localizer transmitter generates a carrier frequency, a portion of which, radiated by one antenna is modulated by a 90 cycle per second signal and another portion, modulated at 150 cycles per second is fed to a second antenna. The modulated carrier frequencies are radiated from a highly directional antennae array in such fashion that the radiation pattern on one side of the runway is predominantly modulated by the 90 cycle per

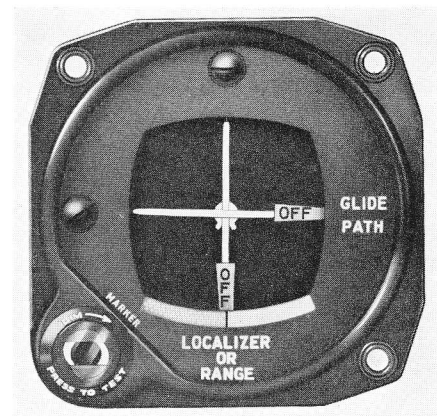
Figure 4—The Weston Model 888 showing inoperative condition of ground or airborne equipment.

The problem of incorporating the beacon lamp assembly in the instrument case was purely mechanical and subject only to those limitations imposed by restricted space. The lamp assembly was finally located in the lower left corner of the case flange as shown in Figures 3 and 4.

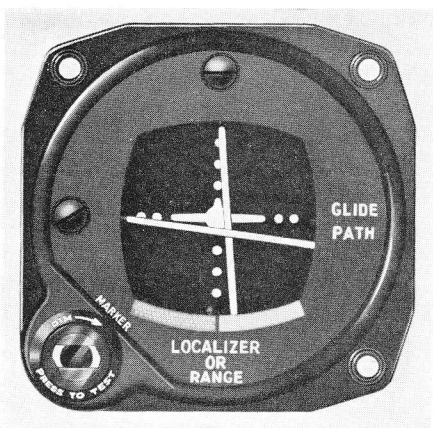
Figure 3—The Weston Model 888 showing operative conditions: ship is slightly above the glide path and slightly left of the localizer course.

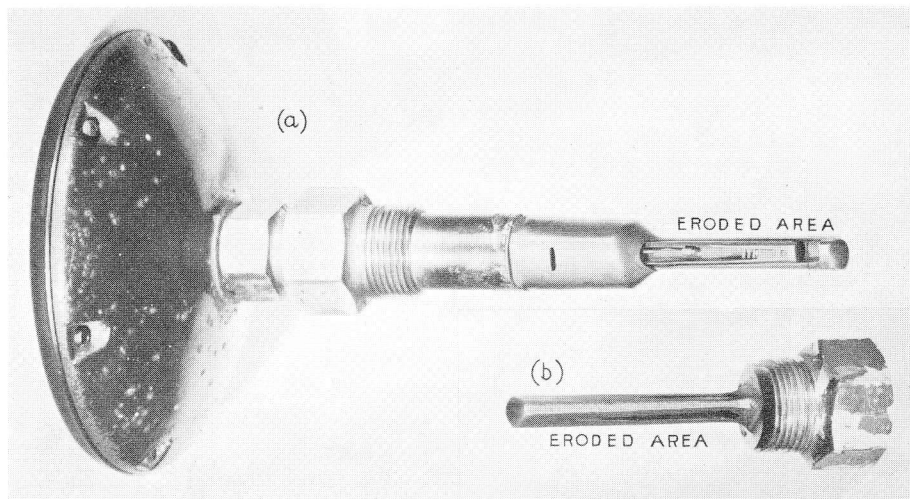
Figure 1—Actual photograph illustrating the effects of improper installation of the Weston Model 222D Industrial Thermometer (a) and a smaller socket similarly eroded (b).

The mechanical erosion of thermometer stems, thermowells and protective sockets by the impact of solid particles conveyed by air blast or suction is a particularly troublesome problem but one which is readily overcome by fairly simple means. When one considers the similarity between air blast conveying systems and the familiar sand or grit blasting where the intention is to provide a controlled abrasion to clean surfaces or otherwise prepare them for subsequent operations, it becomes apparent that the same type of erosion can be anticipated. Erosion caused by particles in the air blast conveying system is continuous and uncontrolled and may cause considerable damage before detection. While ducts of such systems are generally designed with this problem in mind, the accessories such as thermometers are necessarily designed for the primary function, temperature measurement, and must be protected against mechanical erosion by some means of installation designed to minimize the effect of such abrasion. Figure 1-a shows the badly eroded protective socket

and stem of a thermometer removed from an air-pulverized-coal conveying system. Figure 1-b

shows the effects of the improper installation of a protective socket in a similar system.

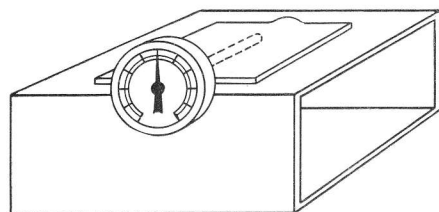
Figure 3—Using the thermometer to indicate surface temperature.

monometer outside of the housing as shown in Figure 3. By attaching the thermometer in such a manner

that the stem rests against the outside metal surface, and covering with a patch of insulation (lagging) the thermometer will indicate skin or surface temperature which in most cases will be within a few degrees of actual powdered coal temperature. If for some physical reason the thermometer must be placed where the stem will be in direct contact with the powdered coal, certain minor variations in adapting the thermometer may alleviate the erosion. A heavy duty, thick-walled socket may be used or a suitable baffle or deflector can be installed. See Figures 4 and 5. The socket or thermowell need be used only if it is desired to be able to remove the thermometer without leaving the resulting opening, Figure 6. In some installations the use of a short stem thermometer has given very good results in retarding erosion by keeping the stem out of the

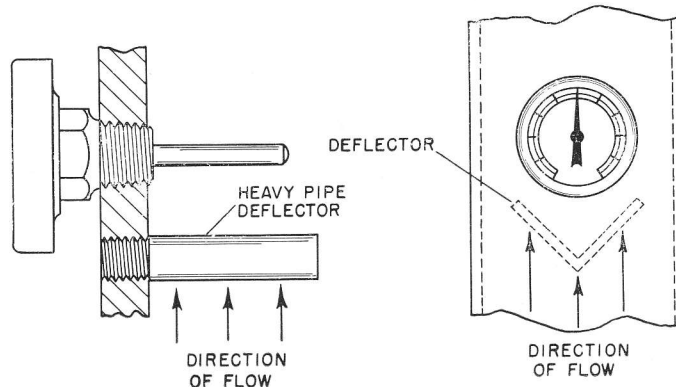
Figure 5—If the thermometer can not be moved it is recommended that deflectors be installed as shown

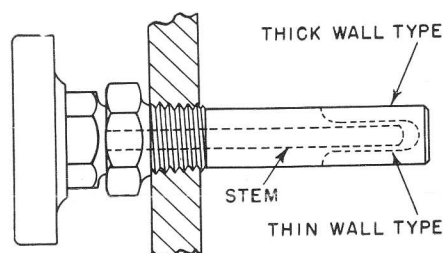
Figure 4—Sketch showing the use of the thermometer with a protective socket.

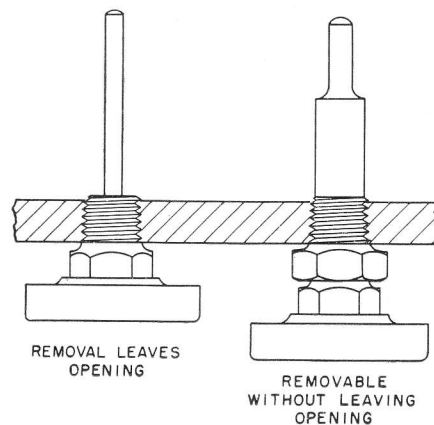
Figure 6—The above sketch illustrates the use of the thermometer with and without its protective socket.

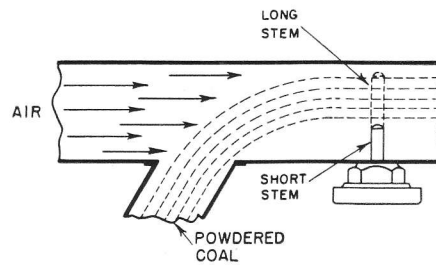
Figure 7—The use of the short stem thermometer is another solution to the erosion problem.

direct flow of coal. Figure 7 shows the installation of a short stem thermometer.

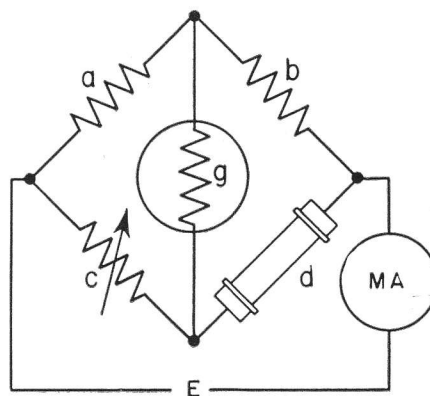
Figure 1—Diagram of Wheatstone Bridge for high resistance measurements at normal operating voltage.

The simplest way to make a test of this sort is to set up a bridge as shown in Figure 1 where  $d$  is the unit under test and

$b$  is a standard wire wound resistor of high accuracy having the same value as the nominal value of the resistance being tested. This may, for example, take the form of a so-called megohm box or a series of such boxes. Let  $a$  and  $c$  be a pair of decade boxes and for working in the megohm range these can be the order

of 10,000 ohms each. Better yet, let  $a$  be an accurate 10,000 ohm resistor and  $c$  consist of a decade box with a top range of something over 10,000 ohms or a fixed resistor of some 8000 ohms and a decade box to go beyond this value. The associated galvanometer should, of course, have an extremely high resistance but in practice galvanometers of as much as 10,000 ohms are not available and one can merely say that the highest resistance galvanometer readily available should be used.

With such an arrangement the bridge is balanced by adjusting arm *c* and when balance is indicated on the galvanometer, if *b* is equal to the nominal value of *d*, the actual value of *d* in terms of *b* is obtained from the value of *c* in terms of *a*. For example, if we are testing a nominal 5 megohm resistor and make *b* accurately 5 megohms, and if *a* is 10,000 ohms as suggested, and a balance is obtained when *c* is 9956 ohms, then *d* is actually 99.56% of its nominal value or 4.978 megohms and is in error by .44% from its nominal value.
